# Rocky Flats Environmental Technology Site

## BUILDING 865 HIGH BAY DEMOLITION PATH-FORWARD PLAN

REVISION 0

June 5, 2003

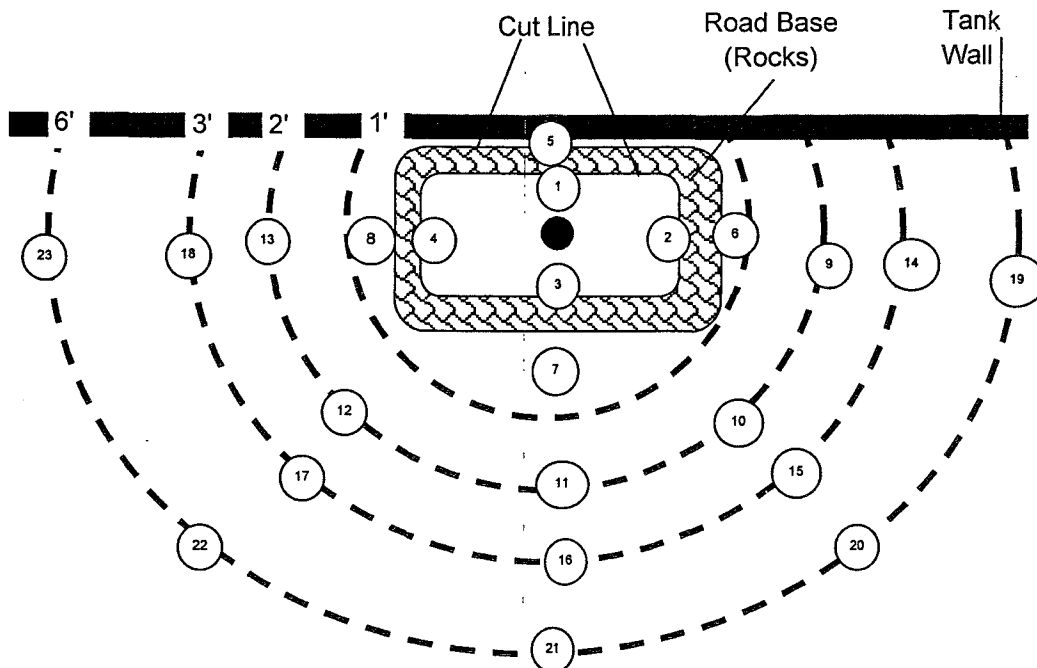
### Expanded View of Drain Line Cut Area

# Indicates areas of contamination

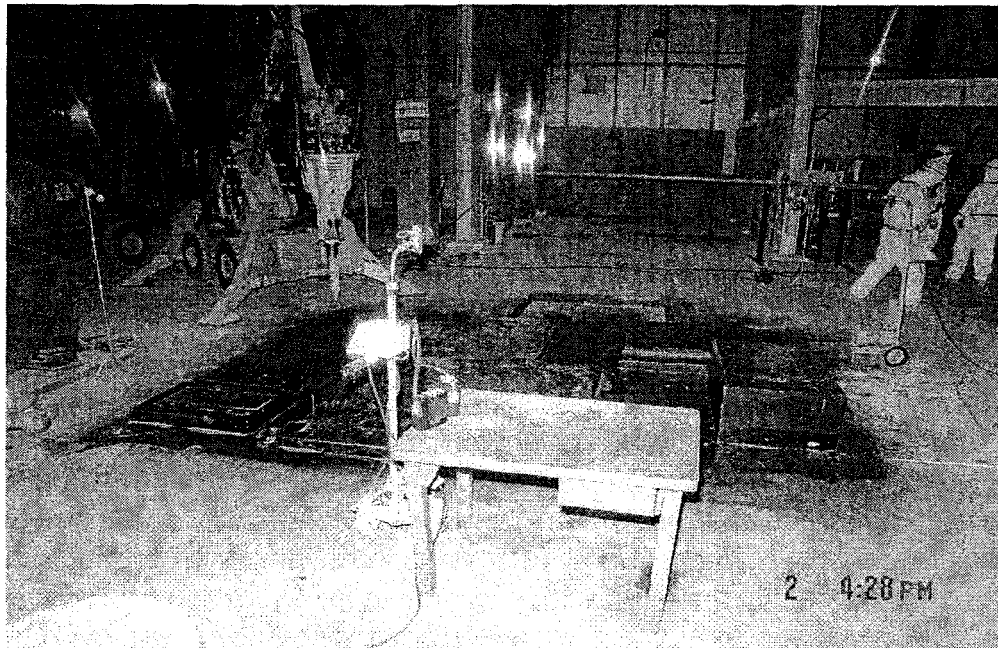
### **Conditions Before Test**

A Brokk Model-250 hydraulic hammer was used to dismantle a contaminated floor area of about 200 Sq. Ft., including floors, pedestals and floor seams with high levels of fixed beta contamination and low levels of Be contamination. Some floor-seam caulking removal was also done with a hammer chisel after the Brokk tests. Contamination from both DU and Be was isolated before the Brokk test by applying a fixative layer of CC-Wet and CC-Fix ~ 1/8" thick. Low-volume radiological air & Be air samplers surrounded the test area on each side.

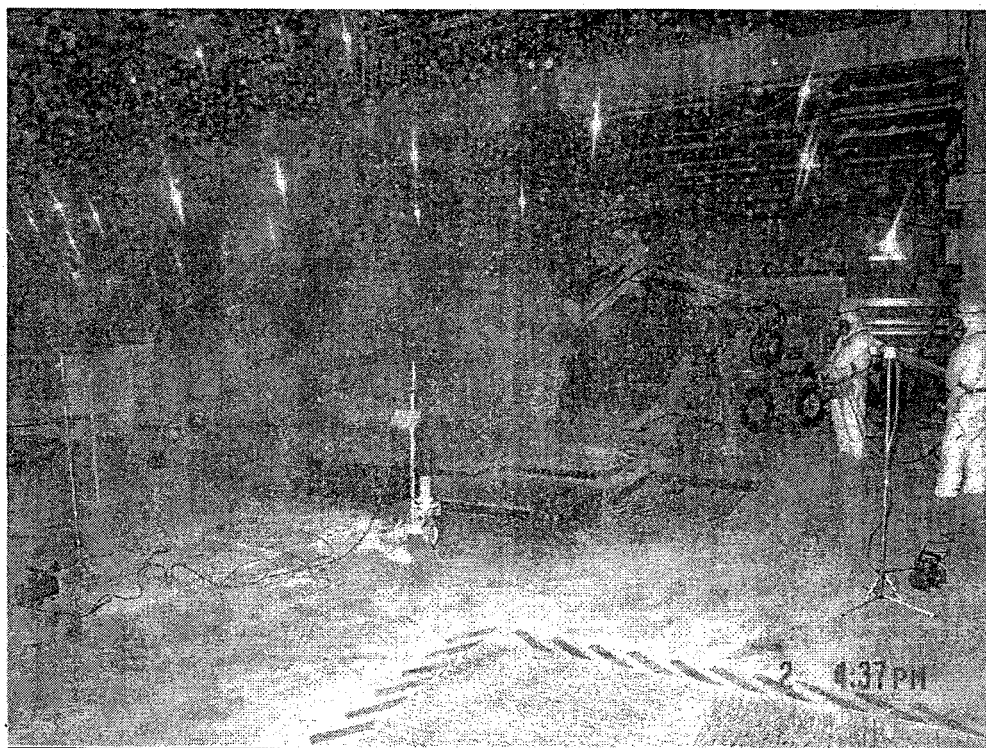
**Conditions At Beginning of Test**

The Brokk-test was done on May 2, 2003 PM Shift, with essential personnel present. The test purpose was to simulate conservative bounding effects for future floor demolition of the slab. It was decided that heavy cement dust from the Brokk hydraulic chisel and hammer-chisel crack disturbance tests should not be suppressed by wetting & misting, in order to allow bounding airborne conditions for DU and Be contamination spread to be measured. Airflow tests done immediately prior to starting floor demo identified the predominant direction of airflow being from the Northwest to the Southeast. Fixed area samplers were placed in the downwind zone. Test personnel as much as practicable avoided the downwind zone. Air samplers for both Be and radiological contaminants were placed very close to the test area perimeter (~1 meter from the edge), as well as further out at about 3 meters. Four area Be air samplers were put into place on each side of the test area, and two low-volume air samplers deployed for radiological purposes (on the south & west sides of the test area). Test personnel were monitored with individual personnel air samplers for both Be and radiological contamination. Personnel wore full Anti-Cs, respirators, hoods, taped openings, and multiple gloves & booties. Full time RCT and IH&S coverage were present throughout the entire test duration of 1-hour.

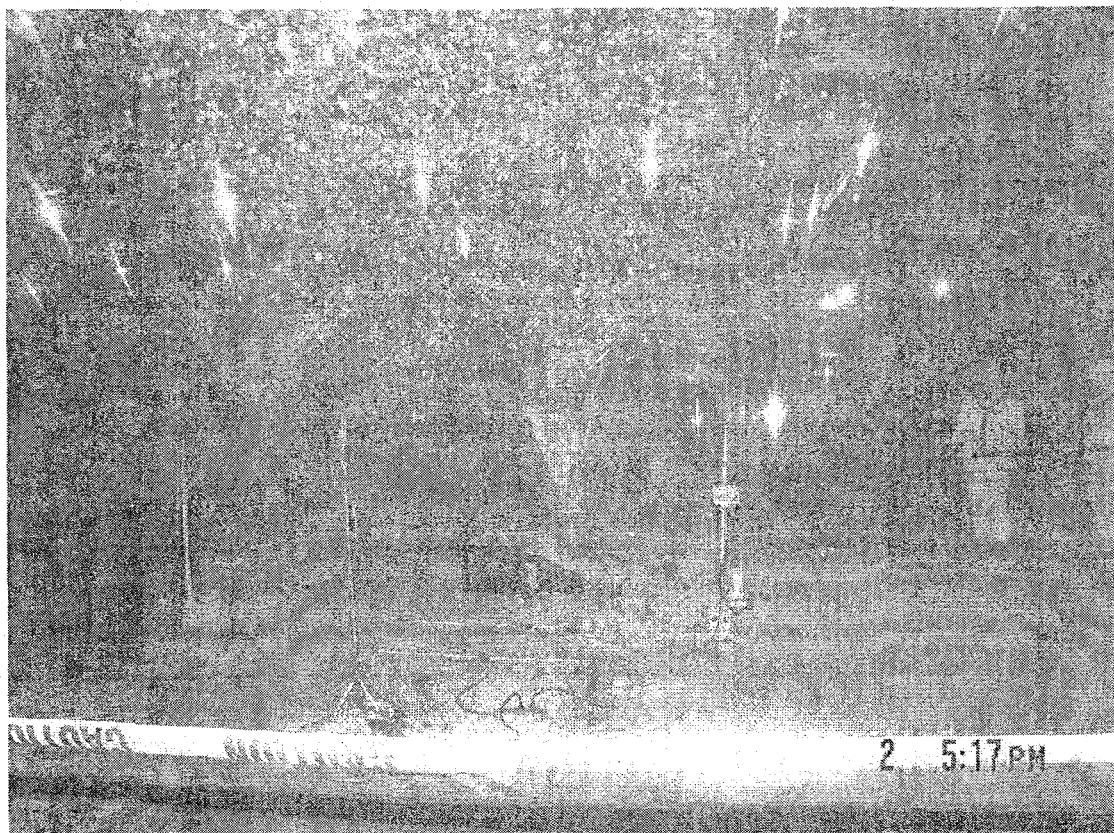
### **Conditions Near End of Test**

Table 6 summarizes contamination conditions after the Brokk test and also includes a summary of contamination from several follow-on electric hammer chisel destructive tests on crack sealant materials. Over 65 swipes for removable contamination were taken on floors pedestals & cracks in Grid #9 following the Brokk and the hammer-chisel tests. All of these swipes except two counted < MDA for *both* removable alpha & removable beta activity. Two of the post-test swipes read about 63 dpm removable alpha activity, an insignificant amount. General area direct alpha readings at thirty floor locations within Grid #9 remained unchanged, still averaging < 100 dpm/100 cm<sup>2</sup>. Fixed beta of general areas in Grid #9 decreased (due to beta self-shielding from disturbed cement) to an average of 2600 dpm/100 cm<sup>2</sup>, as compared with the pre-test average on floor of ~ 8500 dpm/100 cm<sup>2</sup>. Crack & floor-seam average fixed beta contamination levels *increased* in most cases, suggesting that "chasing" beta contamination downwards between slab segments might be labor-intensive and ineffective.

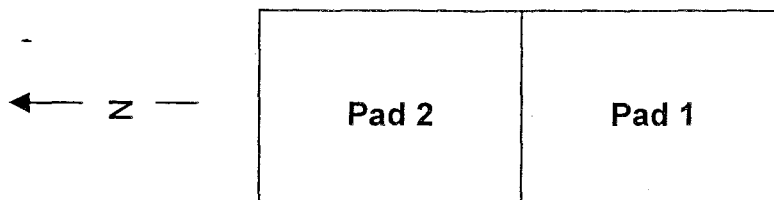
(980 Test Pads – Top View)

The test slab area was divided into two sections (Pad 1 and Pad 2). Pad 1 had multiple layers of product (pink powder, CC Fix, and a top coat of InstaCote SE). Pad 2 had a single layer of InstaCote SE sprayed directly onto the clean slab.

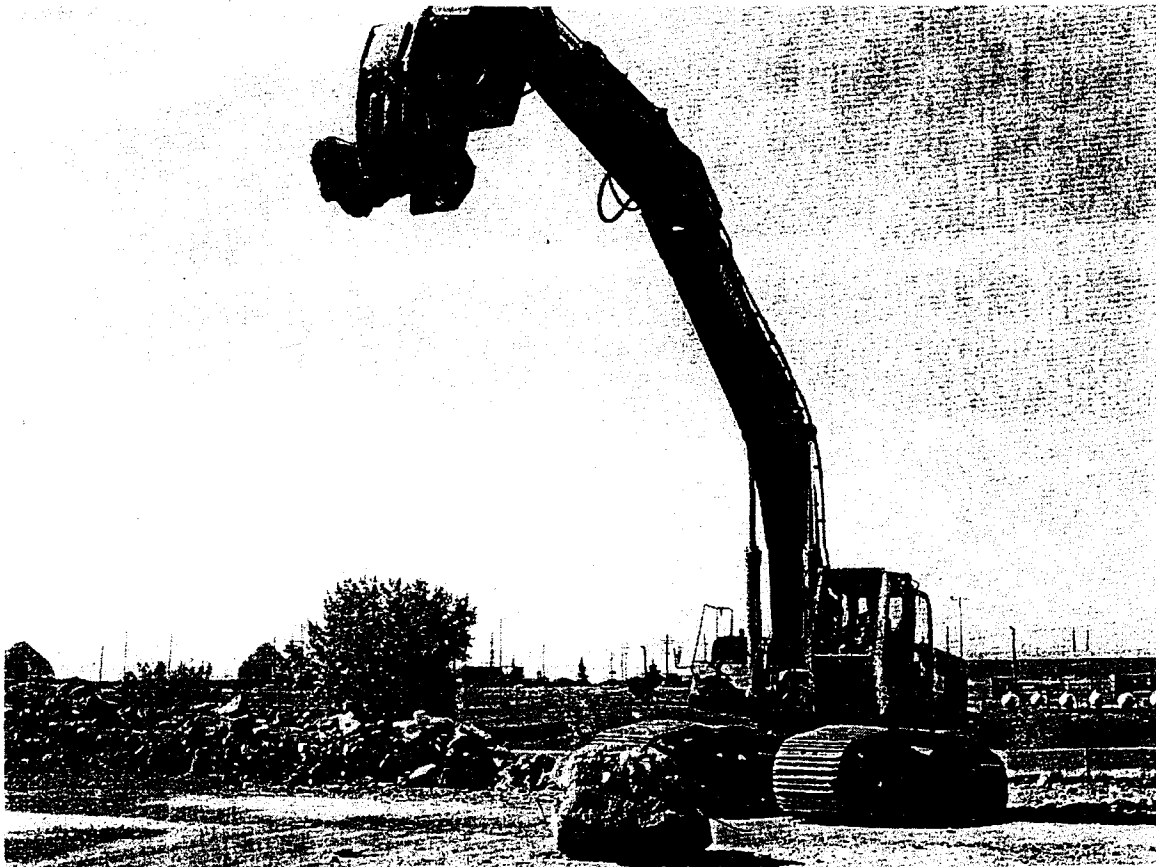
Figure 1. Track-Mounted Processor Dropping Large Rubble Onto Test Pads

The large track-mounted processor was used to lift very large blocks of rubble approximately 15 – 20 feet above the slab. (See Figure 1) Two large chunks were dropped onto Pad 1 and two large chunks were dropped onto Pad 2. Both Pads were inspected immediately after the four objects were dropped.

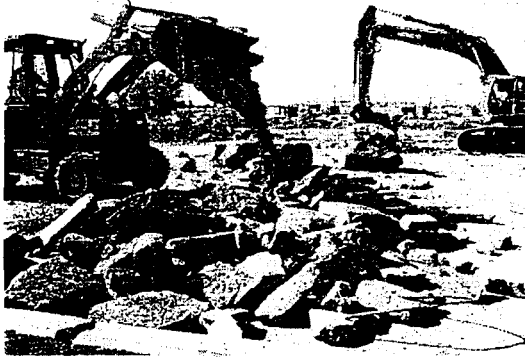
**Figure 4. Dumping Rubble on the Test Pads**

The rubber tired backhoe was used to collect material from the existing rubble pile and dump materials directly onto Pads 1 and 2. Equipment operators were instructed to dump materials as aggressively as possible – lifting each bucket high and dumping the material directly onto the pads. (See Figure 4)

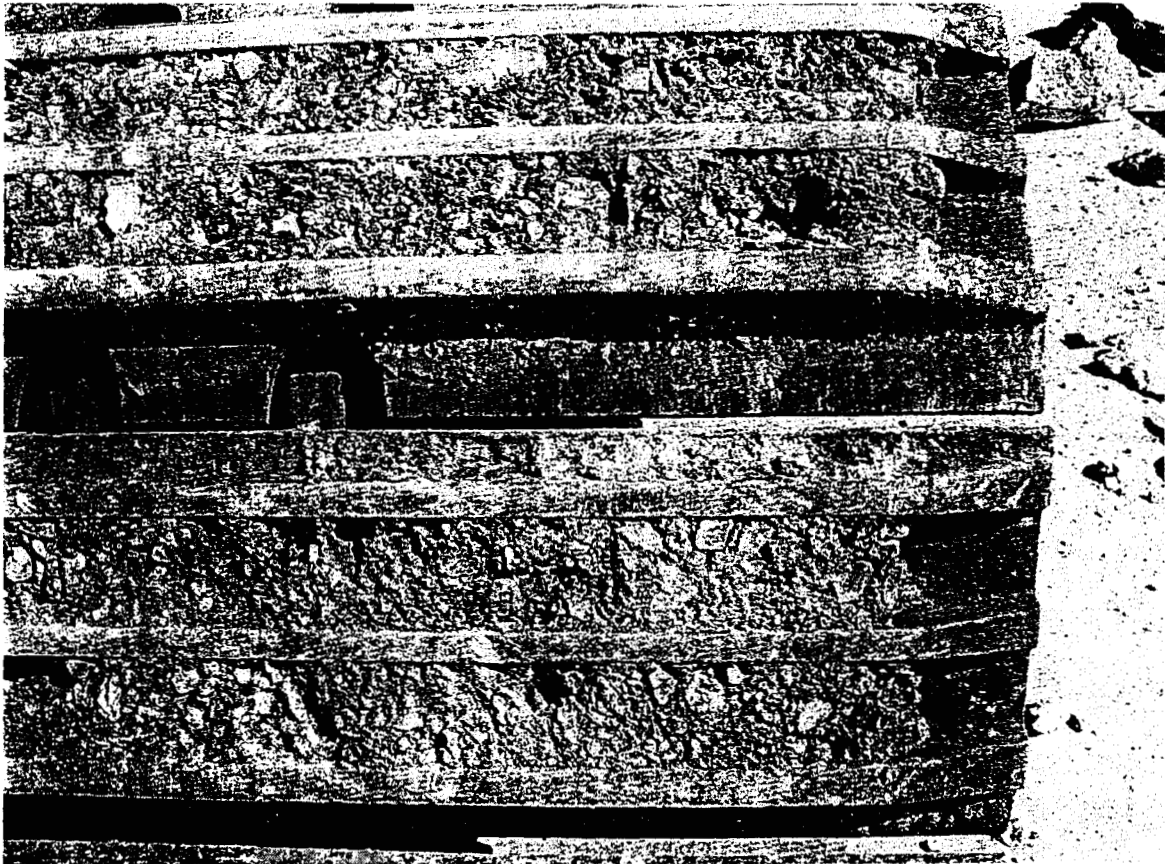
Figure 5. Close-up View of the Treads on the Track-Mounted Processor

This step involved two main phases. Phase 1 had the track-mounted processor drive directly on top of the rubble pile (heading south to north over both pads). The operator was instructed to drive over the top of the rubble, stop, and back up two times.

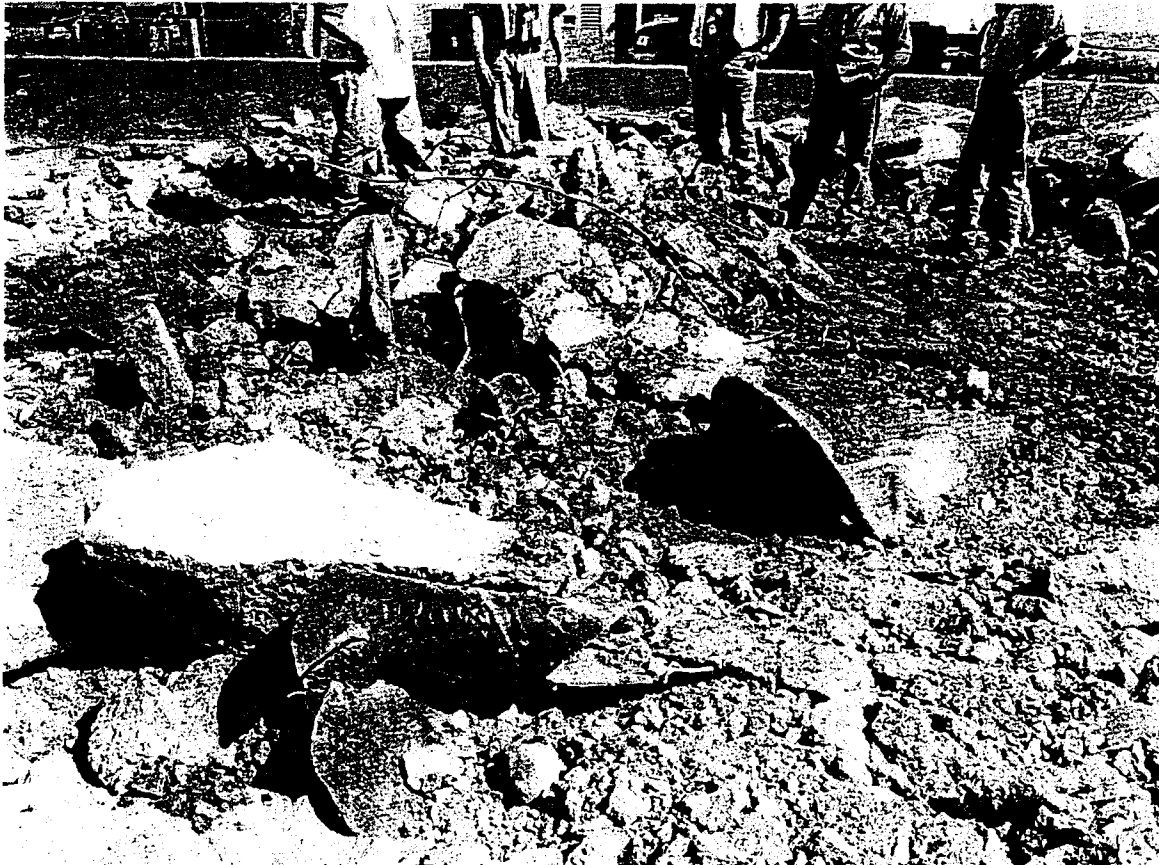
Figure 6. Pad 1 After the Drive and Articulation Phase of Testing - Note Buckling of Coating

Inspection of Pad 1 and Pad 2 was performed after the operator drove off of the test pad area. The coating on Pad 1 was almost completely pulled (or peeled) off of the test pad area during this test (90% damage compared to initial total coverage). Pad 2 fared better. Although the rubble blocked total inspection of Pad 2, it appeared to be in tact.

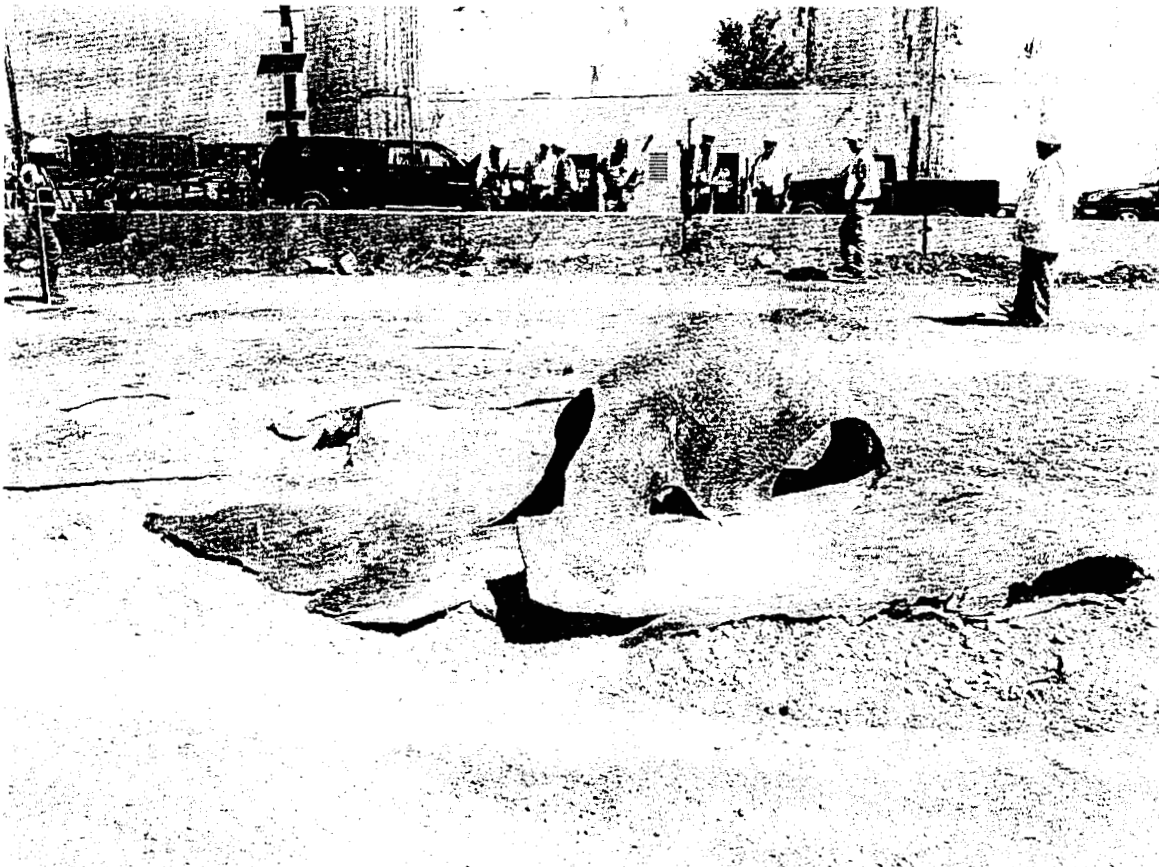
**Figure 7. Pad 1 after Rubble Removal - Most of the Coating Has Been Peeled or Removed from Test Activities**

**PAD 1:** Pad 1 was inspected after removal of the rubble and debris. The entire coating of polyurea and fixative had been peeled up or otherwise compromised. Many sections of the coating were compromised during previous tests (size reduction and articulation of heavy equipment). Removal activities resulted in additional peeling and removal of most of the coating at Pad 1. However, the underlying concrete slab was not significantly damaged or disturbed.

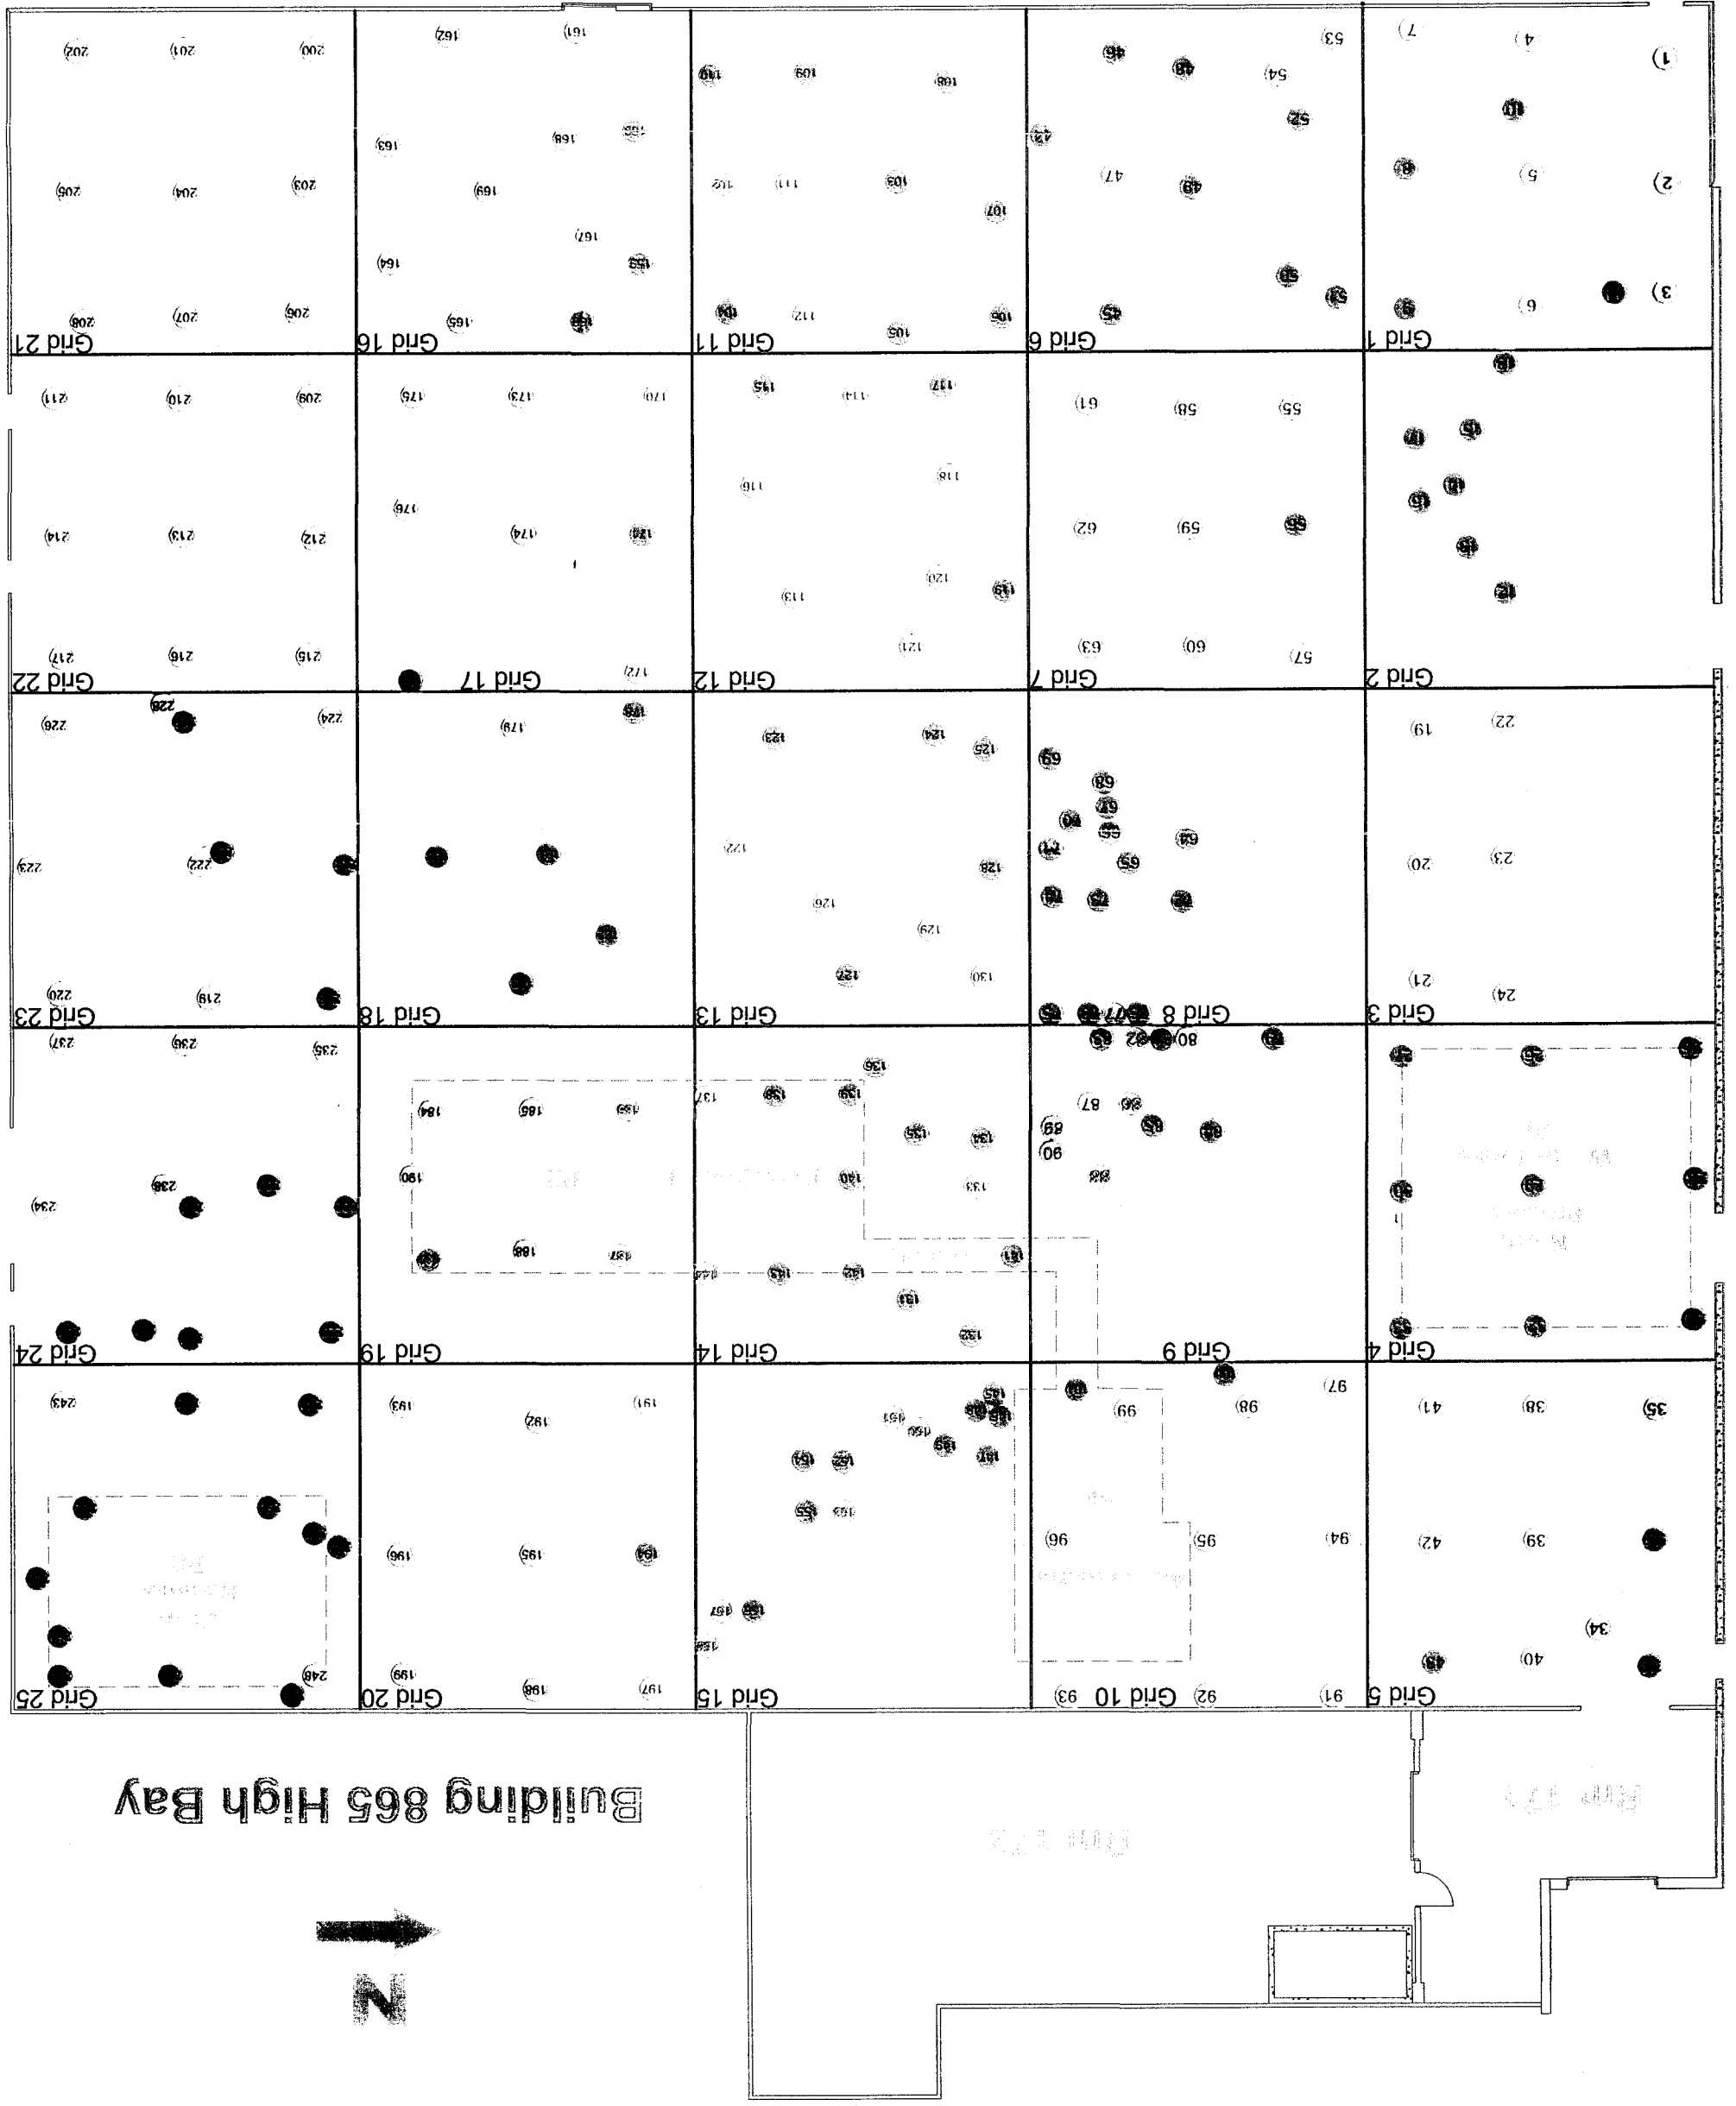
Building 865 High Bay

LEGEND  
(dpm/100 cm<sup>2</sup>)  
> 5,000  
5,000 - 100,000  
101,000 - 200,000  
201,000 - 500,000  
> 500,000

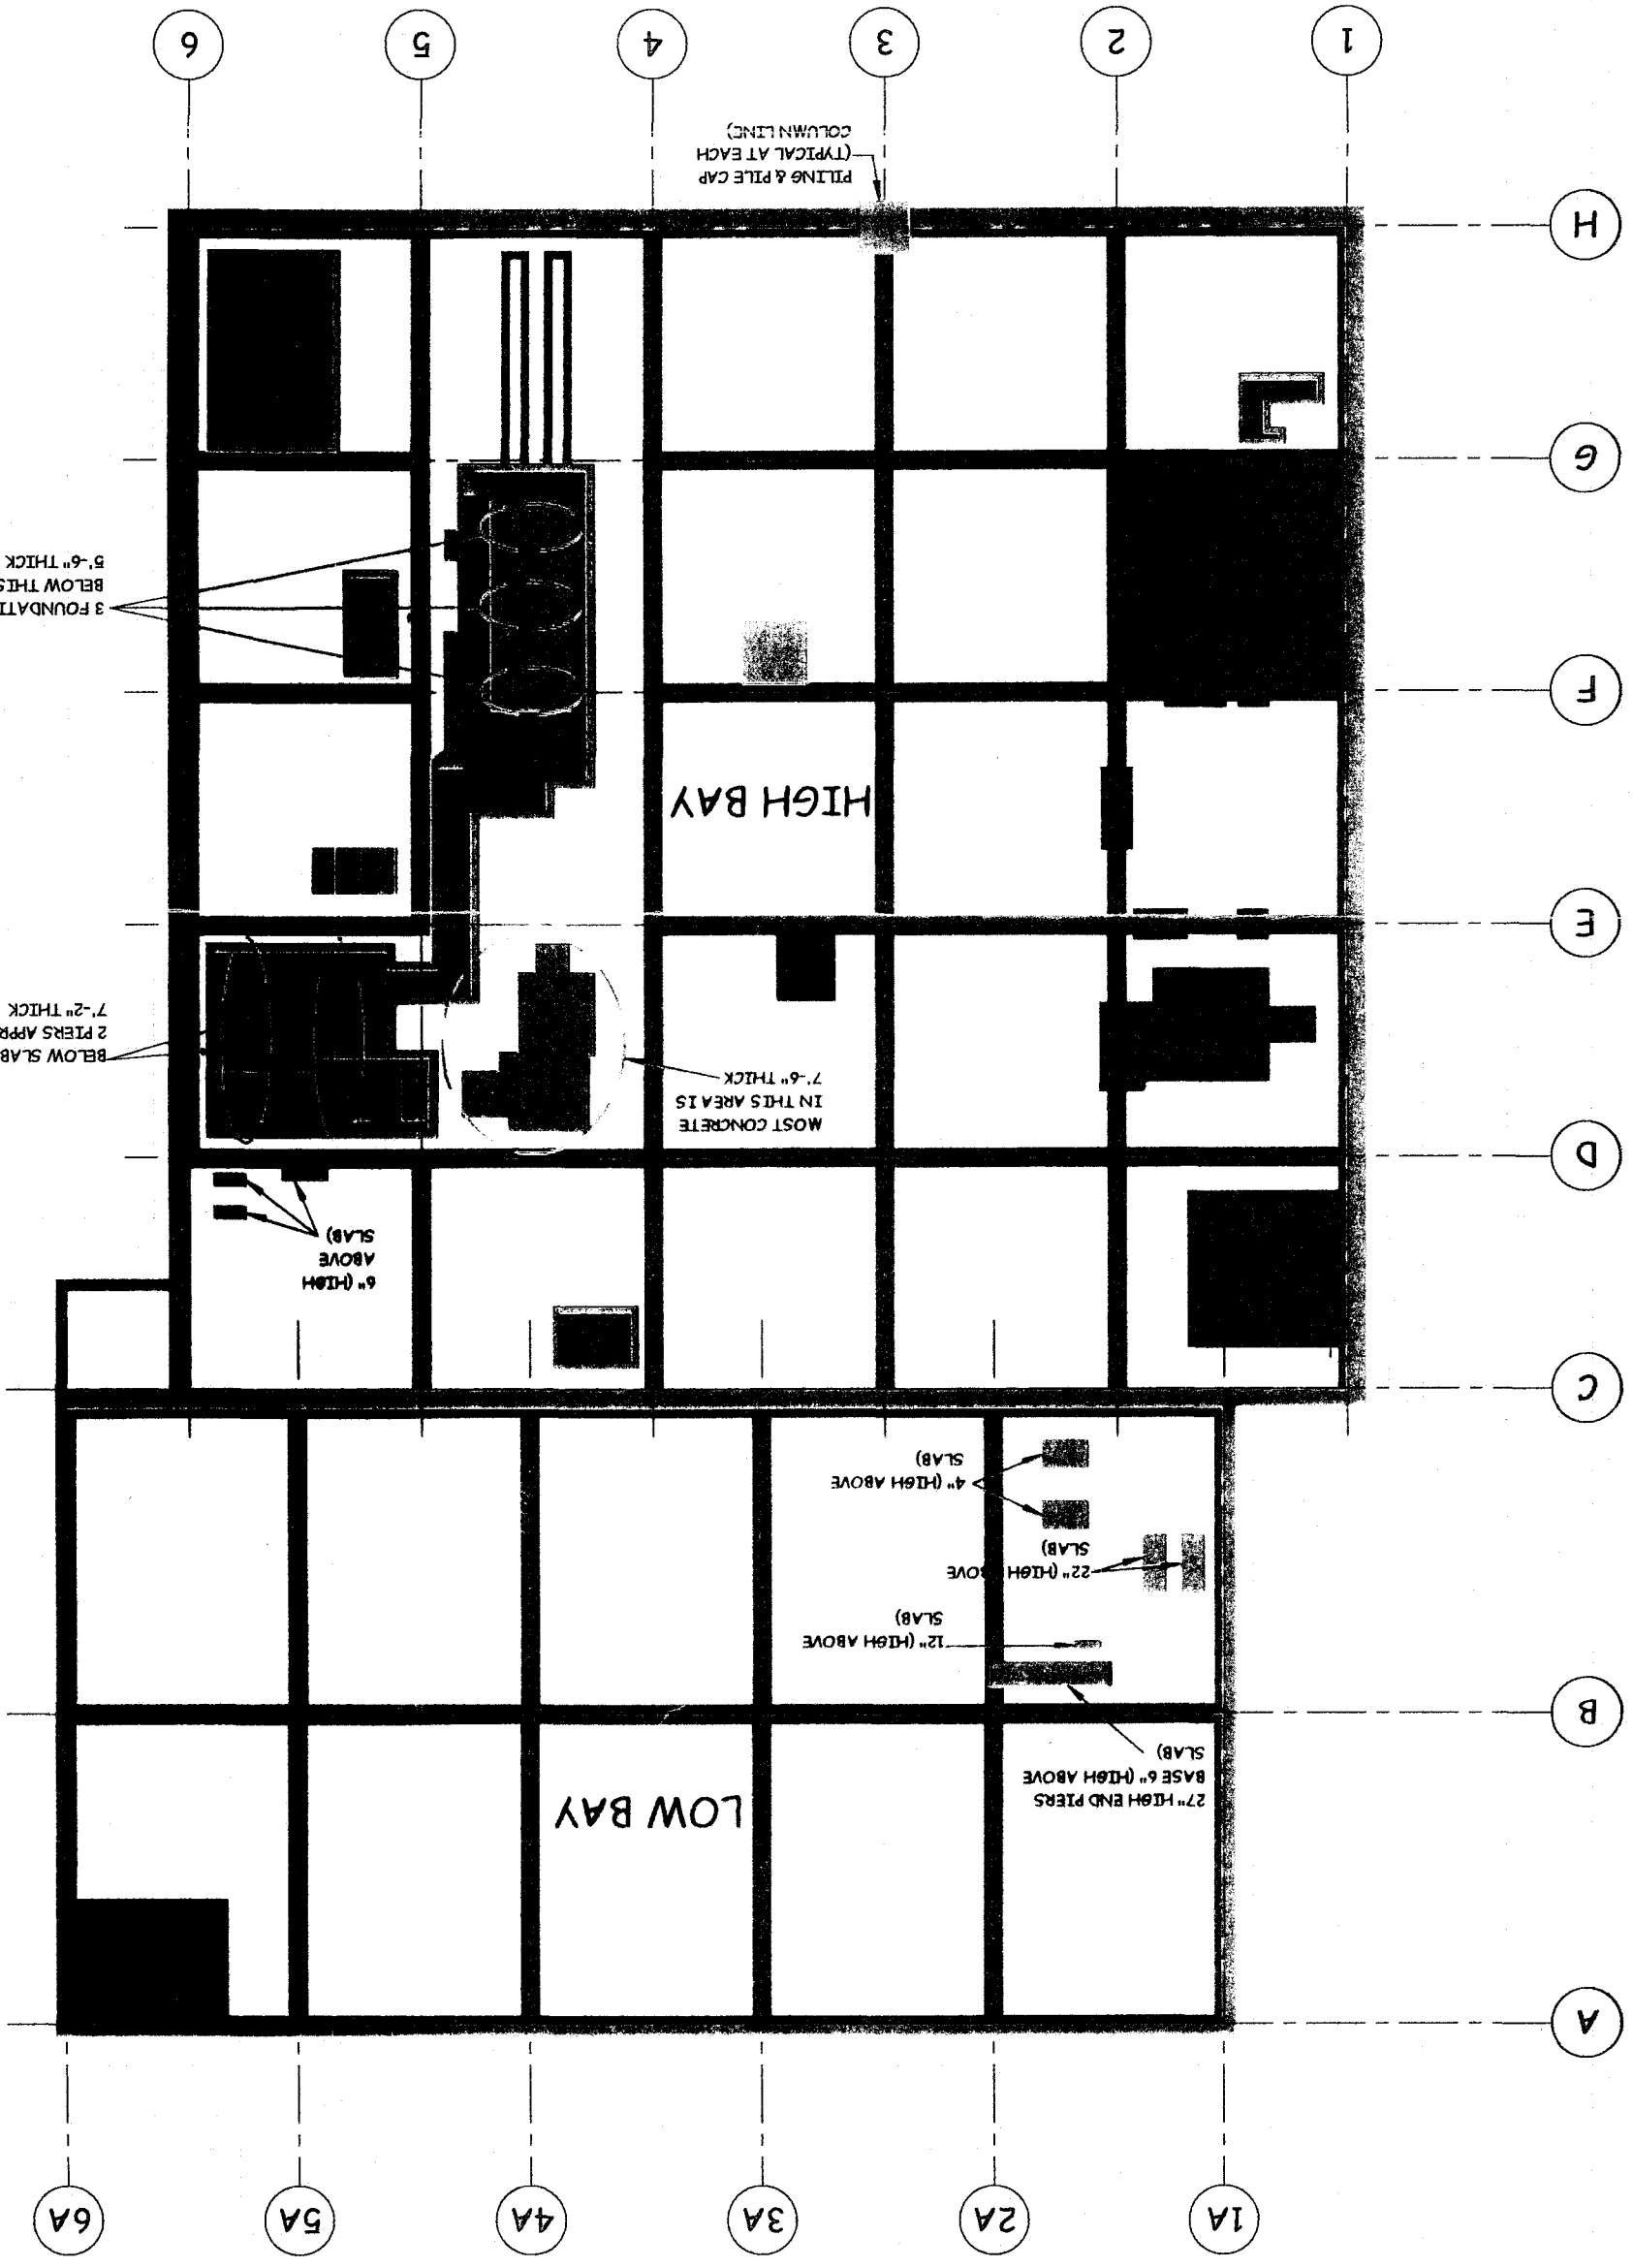
VARIOUS SLAB THICKNESS  
FOR BUILDING 865

- SLAB 6" THICK
- 6" TO 18" THICK
- 18" TO 36" THICK
- ABOVE 36"
- ABOVE SLAB FOUNDATION
- PILES DEPTH (7.5' - 26')  
PILE CAP 2.5' THICK

While an Option 2 scenario is not likely based on what has been observed in other areas of the 865 High Bay slab (i.e., UBC contamination), it is included here as an alternative path-forward. Since there are several very thick pieces of concrete in the pits (>7 feet thick), it was determined that the safest approach for handling these areas was to decontaminate these surfaces below three feet of final grade to unrestricted release levels and leave them in place. There are also some equipment pads on the main floor that are very thick and fall into this same scenario, and may be handled in a similar manner after the portions of the pad above three feet of final grade are removed. Refer to Attachment I for a drawing depicting the various slab thicknesses in the 865 Building.
